Consolidated Edison Of New York, Inc.

SF6 Gas Management Program

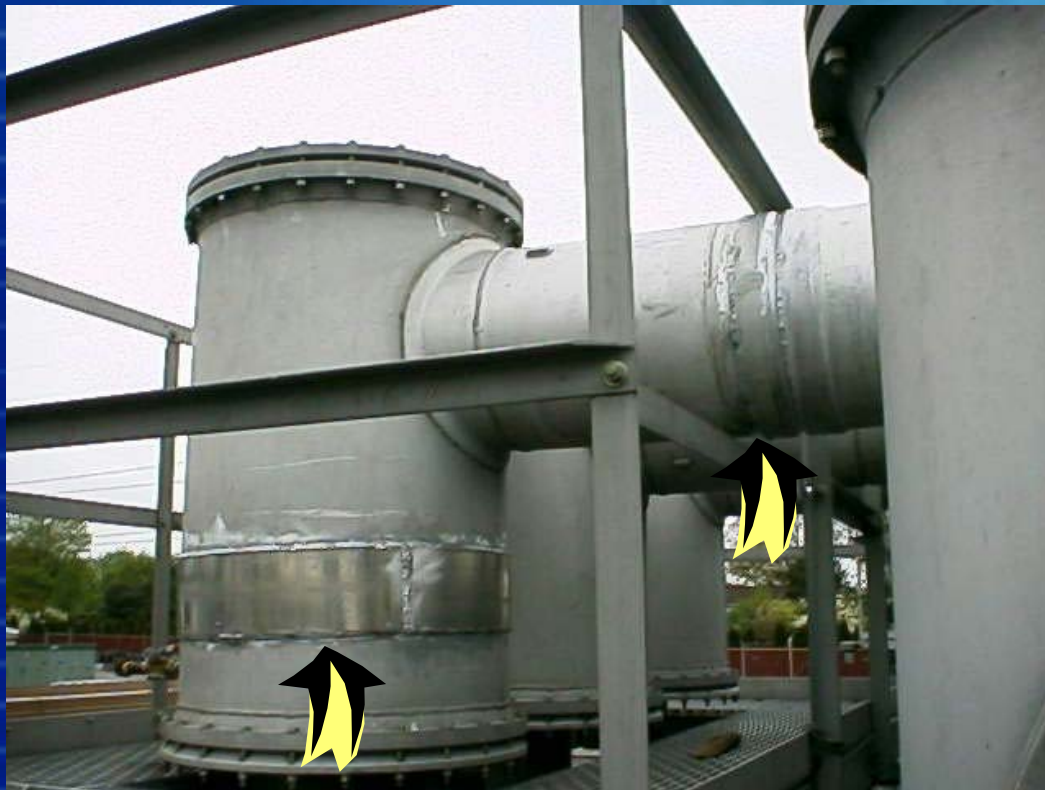
GIS Bus Dunwoodie Substation

- Using the laser camera, field personnel located leaking welds on a GIS bus at Dunwoodie S/S.
- These leaks were repaired by welding bands over the leaking areas.

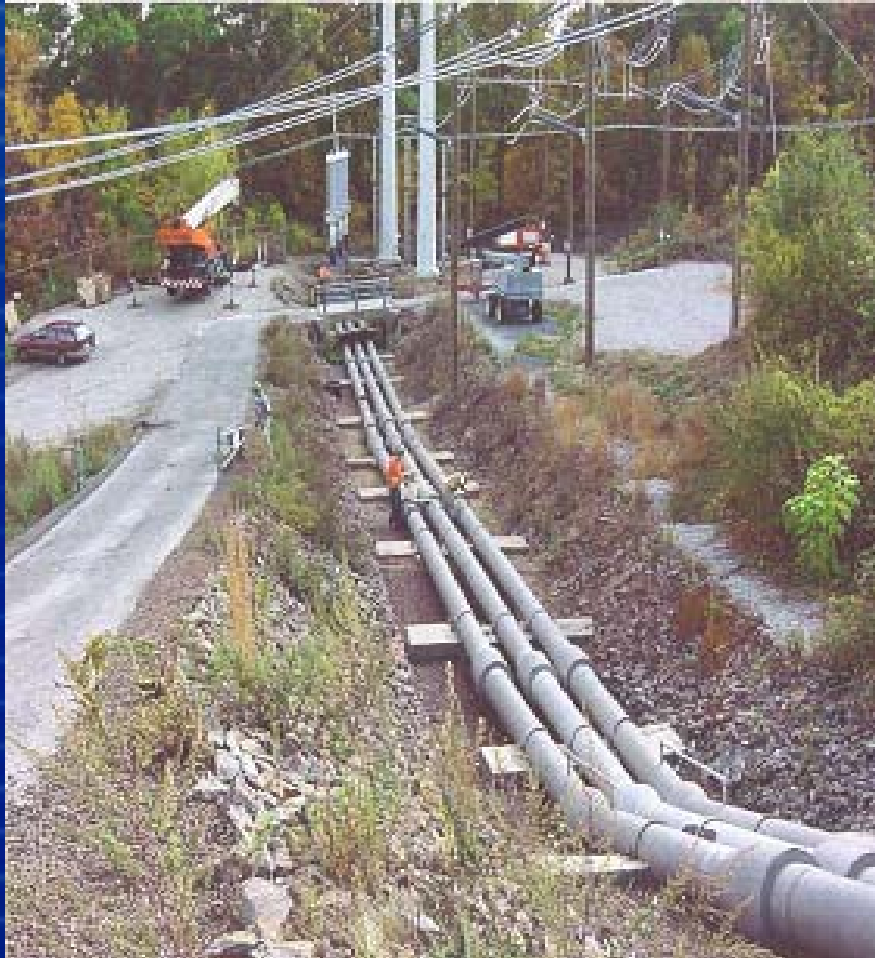
GIS BUS Installation

- GIS feeder installation Y94.
- The over length of the feeder is approximately 1200 ft.
- Approximately 300 gas calls were recorded.

- **First attempt to repair the bus was to use a compound which was developed for natural gas pipe lines, CD5. This compound was applied on two separate occasion with minimal effect.**
- **The second attempted was to repair the leak employed welding the flanged areas of the entrance bushing. This proved to be ineffective.**
- **The third plan was to replaced the six entrance bushings on Y94. This repair cost \$250,000.00 in equipment and \$1,000,000.00 to install the by pass.**
